Manhole Inspection Summary

Manhole # S53AA_006MH

Insp Date: **7/17/08 8:34 AM**

Location Address: **527 n east av**

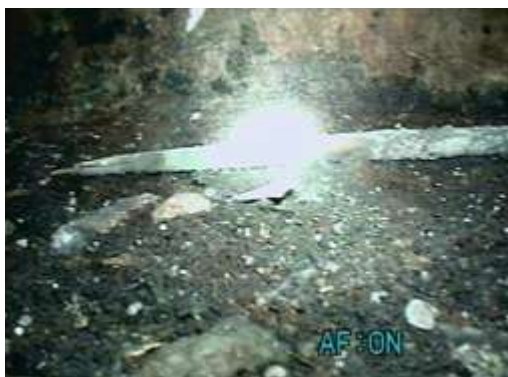
Defect 3

Condition: ☐ Sound ☐ Cracked ☐ Root Intrusion ☐ Deteriorated ☐ Leaks ☒ **Debris**

channel debris

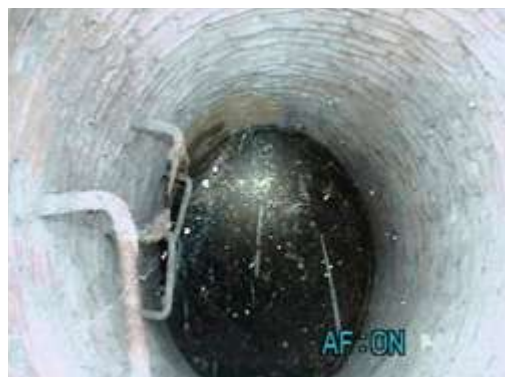
Defect 4

Count: **5** Missing: **1** ☒ **Corroded**

Corroded and 1 missing steps

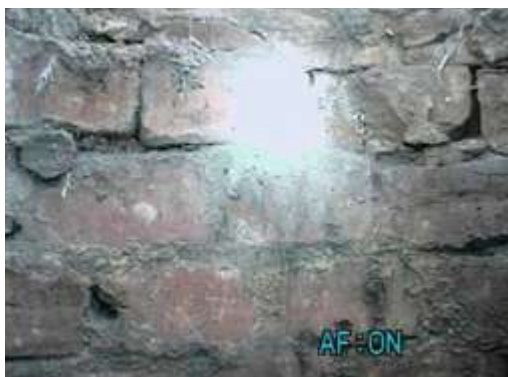
Defect 2

Condition: ☐ Sound ☒ **Cracked** ☐ Root Intrusion ☐ Loose Brick ☐ Deteriorated

corbel cracked

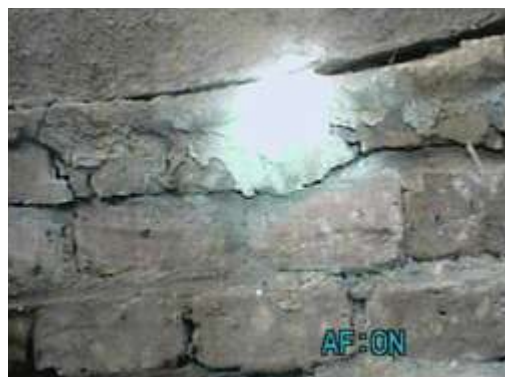
Defect 1

Condition: ☐ Sound ☒ **Cracked** ☐ Root Intrusion ☐ Loose Brick ☐ Deteriorated

Chimney cracked, frame adj
